Status Report on Mercury Target Development and Related Issues

SPALLATION NEUTRON SOURCE

July 31, 2002

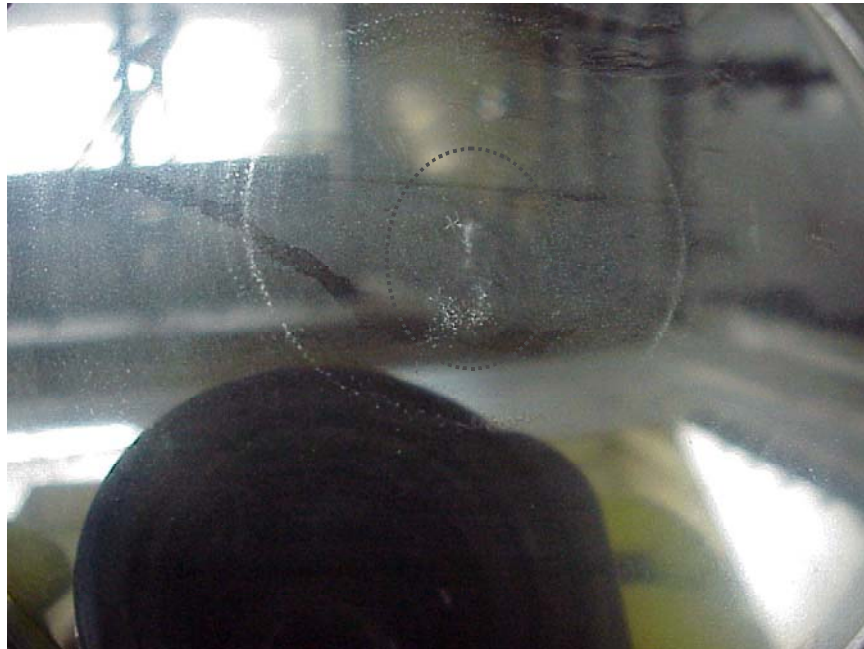
Fig. 3. Front Flange of LE3

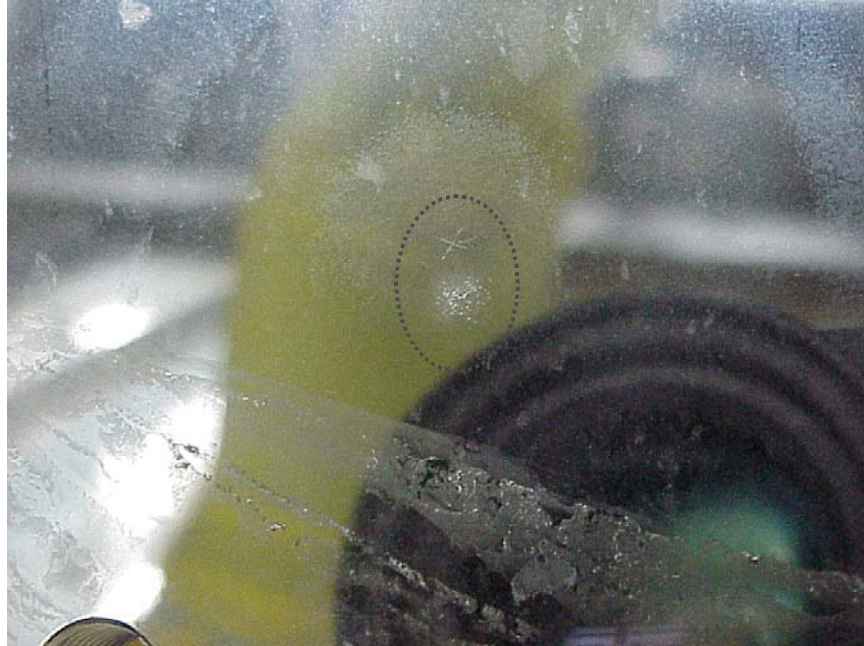
Fig. 4. Rear Flange of LE3
